Ironwork reinstatement

Road ironwork such as manhole covers, road gullies and duct covers need to be bedded with a resilient mortar to prevent the unit rocking or breaking up

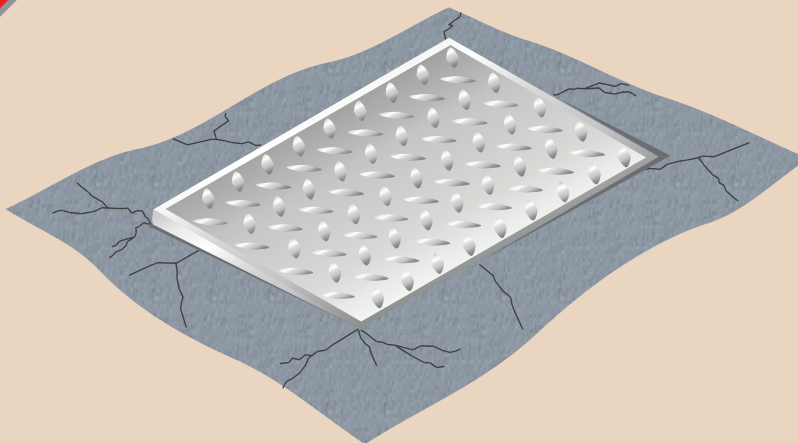
1 Loose ironwork

Cracks in the pavement and movement of the manhole frame can result in the frame becoming loose.

This results in the cover and frame 'rocking' and causing road noise as the unit is trafficked.

The pavement begins to rapidly break up, causing failure.

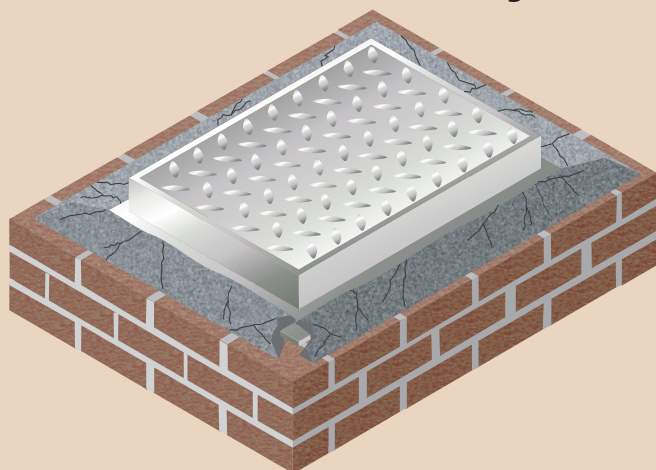
2 Failure in the sand/cement bedding mortar

Site-mixed sand/cement bedding mortar cracks and crumbles under traffic loads, resulting in premature failure of the cover and frame.

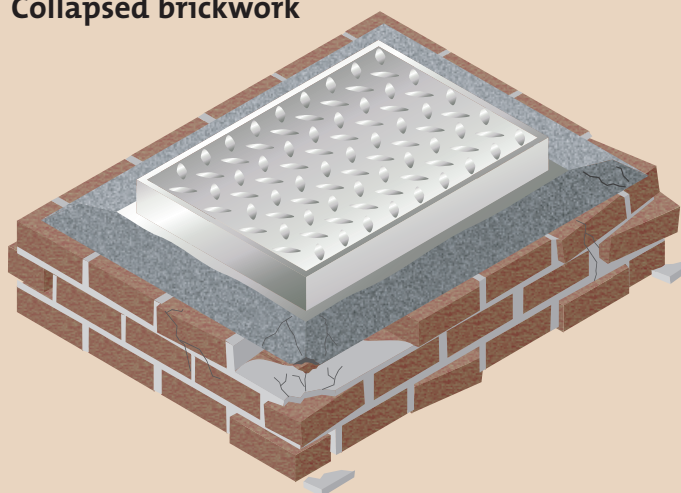
3 Collapsed brickwork

Old brick chambers can collapse under traffic loads or become dislodged during reinstatement works.

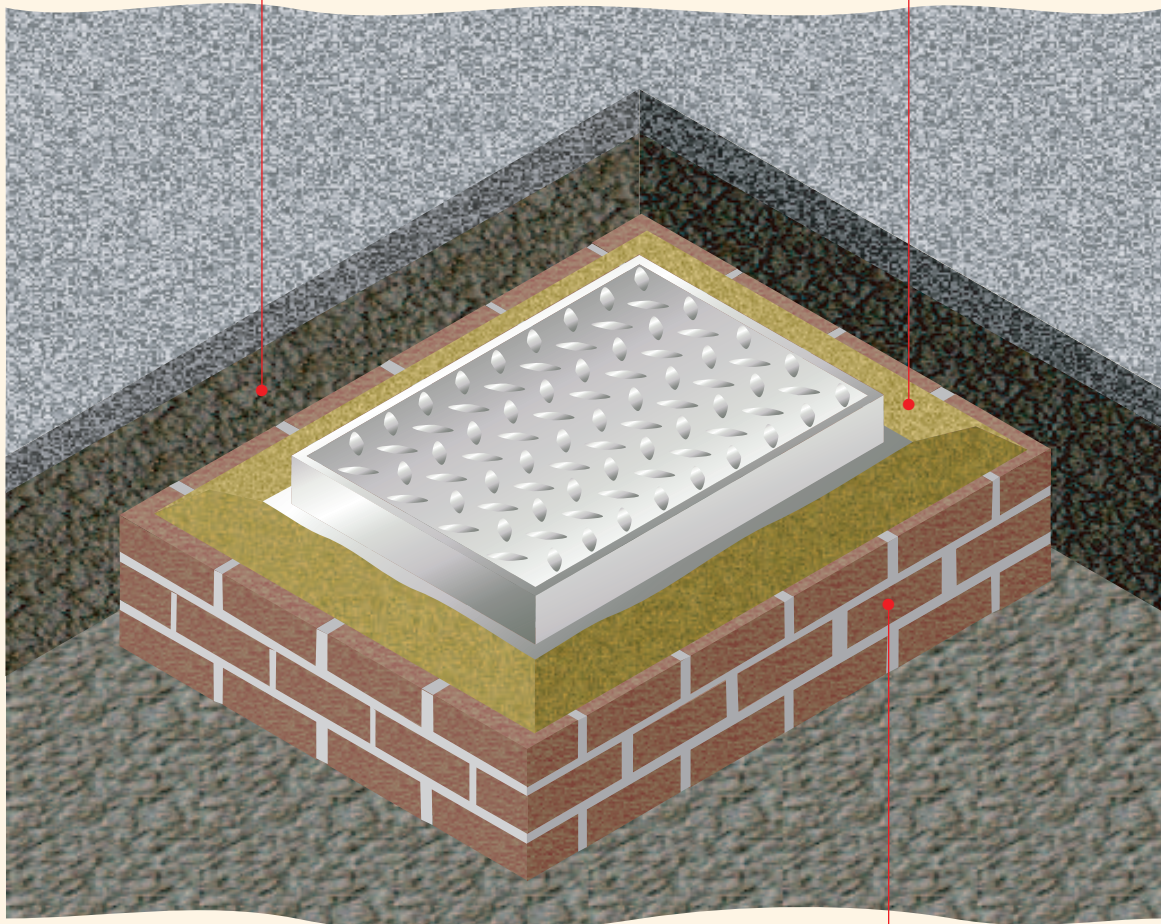
Reinstatement concrete

Back-fill around ironwork with rapid-setting concrete **weber.cem pyracrete** or **weber.cem pyrapatch**.

Bedding mortar

Use **weber.cem pyrabed** applied between 10 mm and 100 mm thick to bed down frame.

Brickwork

Take out loose and broken bricks and reinstate bricks with **weber.cem pyrabed T60** or **T90** mortar.
